**Flood Control Project Maintenance
Levee Inspections**

Maintenance Issue Types Only, Levee Inspection Report By Mile - Spring 2016

Reclamation District No. 0501 Ryer Island

Waterway	Bank	Unit Miles	Inspection Start/End	Inspector
Unit No. 01 Steamboat Slough	Right	6.71	03/24/2016 03/24/2016	Herman Phillips

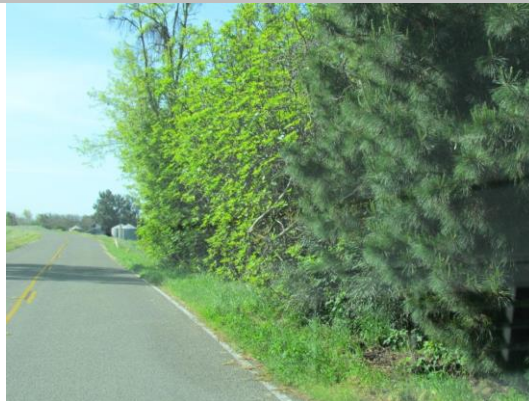
Photo 1 of 1 : SP_2016_RD0501_169_42_20160329_00059.jpg

LM Start	0.04	Rating **	U	Issue No.	42
LM End	0.31	Issue Type +	Ma	Location *	LS
Category	Earthen Levee			GPS Latitude/Longitude	
				Start	End
Item	Vegetation			38.254015 °	38.250288 °
				-121.601850 °	-121.603127 °
DWR ID	DWR_RD0501_01_s_2016_42				
Comment Code					
V1 : Control annual grass and weeds on the levee slopes and easements.					
Inspector Comment					
Control the woody tree growth on the landward levee slope.

Looking downstream from levee mile 0.04 -0.31 woody tree growth on the landward levee shoulder and slope.

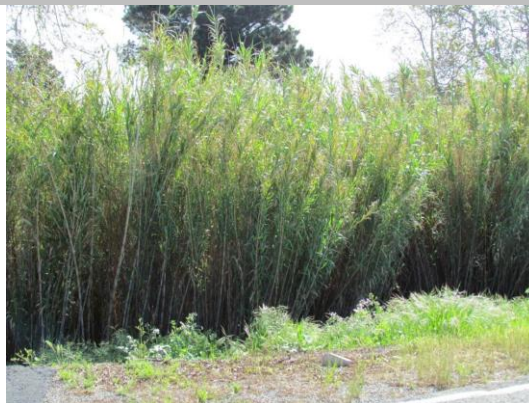
Photo 1 of 1 : SP_2016_RD0501_169_51_20160404_00060.jpg

LM Start	1.55	Rating **	U	Issue No.	51
LM End	1.74	Issue Type +	Ma	Location *	LS
Category	Earthen Levee			GPS Latitude/Longitude	
				Start	End
Item	Vegetation			38.232577 °	38.229883 °
				-121.603480 °	-121.603927 °
DWR ID	DWR_RD0501_01_s_2016_51				
Comment Code					
V2 : Remove the wild growth other than native grasses from the levee slopes.					
Inspector Comment					
Remove the bamboo from the levee section.

Looking downstream the landside shoulder tall bamboo present on the slope.

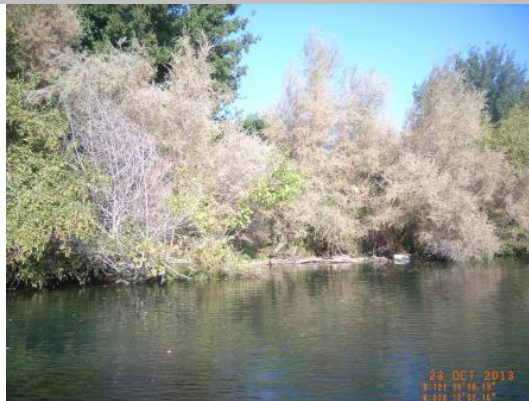
Photo 1 of 1 : SP_2016_RD0501_169_3_20160223_00003.jpg

LM Start	2.85	Rating **	M	Issue No.	3
LM End	2.91	Issue Type +	Ma	Location *	WS
Category	Supplemental			GPS Latitude/Longitude	
				Start	End
Item	2015 USACE Erosion Survey, DRAFT			38.214838 °	38.214075 °
				-121.608129 °	-121.608750 °
DWR ID	DWR_RD0501_01_s _ 2016_3				
Comment Code					
Inspector Comment					
2009 - Rock is starting to unravel, probably from a tree pop-out, hard toe. 2015: No observed changes. [2015 Site ID: STM_18-9_R]

USACE 2013 Photo #1

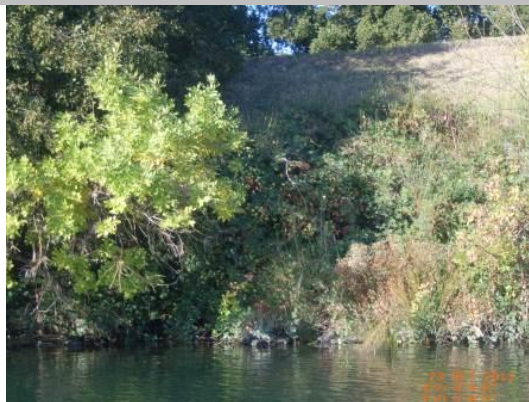
Photo 1 of 1 : SP_2016_RD0501_169_2_20160223_00002.jpg

LM Start	3.04	Rating **	M	Issue No.	2
LM End	3.11	Issue Type +	Ma	Location *	WS
Category	Supplemental			GPS Latitude/Longitude	
				Start	End
Item	2015 USACE Erosion Survey, DRAFT			38.212573 °	38.211596 °
				-121.609760 °	-121.609928 °
DWR ID	DWR_RD0501_01_s _ 2016_2				
Comment Code					
Inspector Comment					
2000 - Slow erosion of lower and mid-slope with rock bench at the low water line. 2015: No observed changes. [2015 Site ID: STM_18-8_R]

USACE 2013 Photo #1

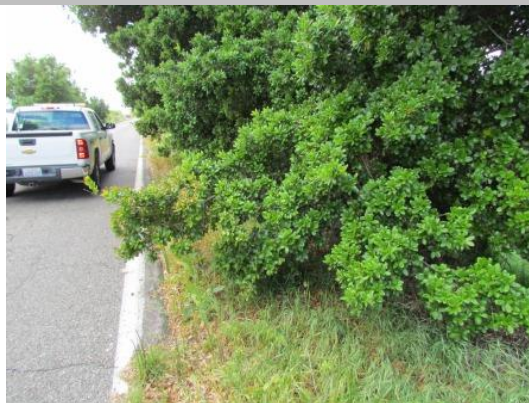
Photo 1 of 1 : SP_2016_RD0501_169_43_20160223_00005.jpg

LM Start	3.33	Rating **	M	Issue No.	43
LM End	3.35	Issue Type +	Ma	Location *	LS
Category	Earthen Levee			GPS Latitude/Longitude	
				Start	End
Item	Trim / Thin Trees			38.208468 °	38.208292 °
				-121.611348 °	-121.611437 °
DWR ID	DWR_RD0501_01_s_2012_43				
Comment Code					
T1 : Trim trees to at least five feet above ground level.					
Inspector Comment					
Trim trees 5-feet above ground, can't see levee slope.

Woody tree growth on levee slope and shoulder of the landside. No new photo taken.

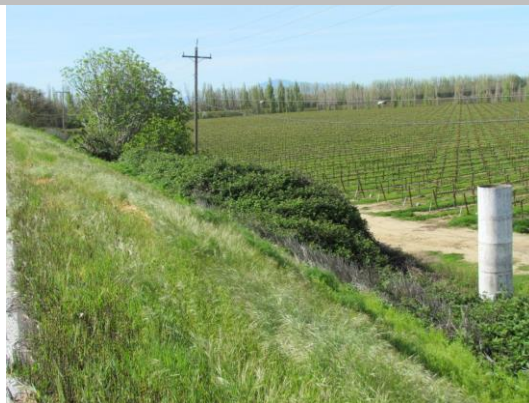
Photo 1 of 1 : SP_2016_RD0501_169_66_20160404_00067.jpg

LM Start	3.44	Rating **	U	Issue No.	66
LM End	3.63	Issue Type +	Ma	Location *	LS
Category	Earthen Levee			GPS Latitude/Longitude	
				Start	End
Item	Vegetation			38.206953 °	38.204293 °
				-121.612042 °	-121.613052 °
DWR ID	DWR_RD0501_01_s_2016_66				
Comment Code					
V2 : Remove the wild growth other than native grasses from the levee slopes.					
Inspector Comment					
Remove the wild berries from the levee slope and toe landward.

Looking downstream from the landside slope levee mile 3.44 wild berries present along the slope and toe.

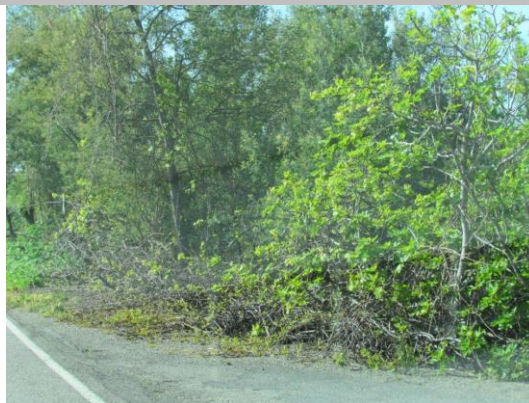
Photo 1 of 1 : SP_2016_RD0501_169_67_20160404_00068.jpg

LM Start	3.73	Rating **	U	Issue No.	67
LM End	4.07	Issue Type +	Ma	Location *	LS
Category	Earthen Levee			GPS Latitude/Longitude	
				Start	End
Item	Trim / Thin Trees			38.202877 °	38.198385 °
				-121.613475 °	-121.615680 °
DWR ID	DWR_RD0501_01_s _ 2016_67				
Comment Code					
T2 : Thin trees to allow visibility of the ground and room to flood fight.					
Inspector Comment					
The woody growth of fig trees need to be removed from the shoulder and slope.

Looking downstream from the landside shoulder and slope levee mile 3.73 unwanted fig trees.

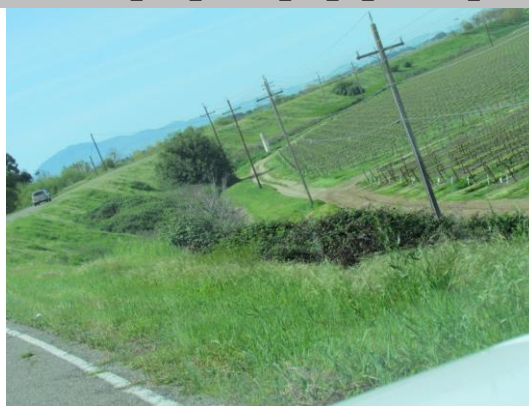
Photo 1 of 1 : SP_2016_RD0501_169_69_20160404_00071.jpg

LM Start	4.14	Rating **	U	Issue No.	69
LM End	4.17	Issue Type +	Ma	Location *	LS
Category	Earthen Levee			GPS Latitude/Longitude	
				Start	End
Item	Vegetation			38.197492 °	38.197160 °
				-121.616340 °	-121.616675 °
DWR ID	DWR_RD0501_01_s _ 2016_69				
Comment Code					
V2 : Remove the wild growth other than native grasses from the levee slopes.					
Inspector Comment					
Remove these wild berries from the landside slope and toe.

Berry vines present on the toe of the landside slope and toe.

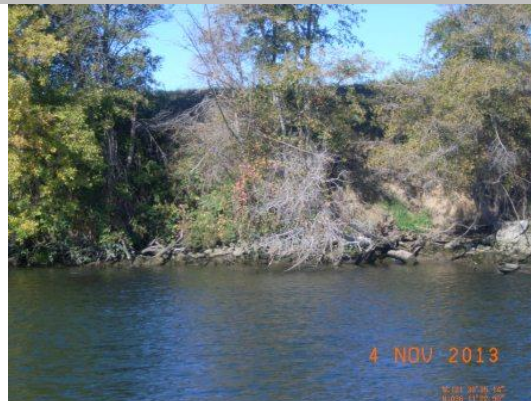
Photo 1 of 1 : SP_2016_RD0501_169_1_20160223_00001.jpg

LM Start	5.77	Rating **	M	Issue No.	1
LM End	5.84	Issue Type +	Ma	Location *	WS
Category	Supplemental			GPS Latitude/Longitude	
				Start	End
Item	2015 USACE Erosion Survey, DRAFT			38.190001 °	38.189311 °
				-121.643160 °	-121.643917 °
DWR ID	DWR_RD0501_01_s_2016_1				
Comment Code					
Inspector Comment					
2008 - Overstepped levee section with multiple small pockets of erosion 10 - 20 ft wide. 2013 - Site has fresh erosion and taller vertical sections. 2015: No observed changes. [2015 Site ID: STM_15-7_R]

USACE 2013 Photo #1

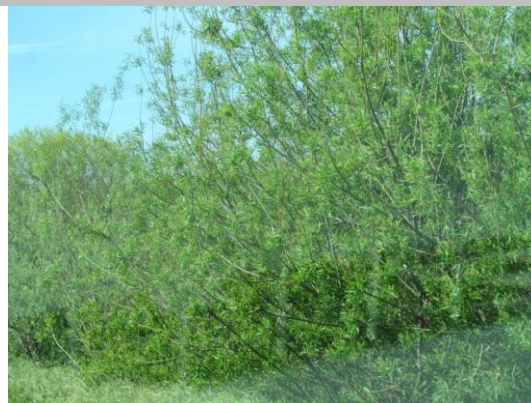
Photo 1 of 1 : SP_2016_RD0501_169_72_20160504_00072.jpg

LM Start	5.88	Rating **	U	Issue No.	72
LM End	5.93	Issue Type +	Ma	Location *	LS
Category	Earthen Levee			GPS Latitude/Longitude	
				Start	End
Item	Vegetation			38.188912 °	38.188380 °
				-121.644687 °	-121.645243 °
DWR ID	DWR_RD0501_01_s_2016_72				
Comment Code					
V7 : Trees / Woody Vegetation					
Inspector Comment					
Control the woody tree growth on the landside slope.

Looking downstream from the landside slope levee mile 5.88 to 5.93 woody tree growth on the levee section.

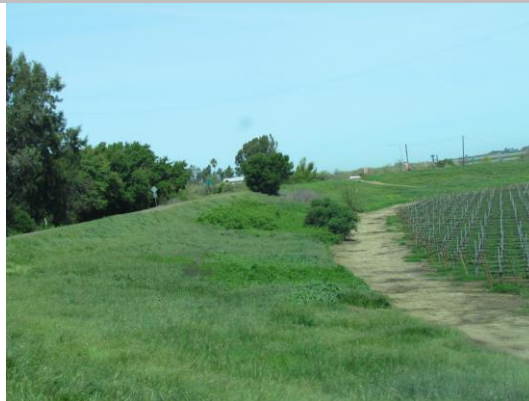
Photo 1 of 1 : SP_2016_RD0501_170_21_20160504_00043.jpg

LM Start	0.00	Rating **	M	Issue No.	21
LM End	0.00	Issue Type +	Ma	Location *	LS
Category	Earthen Levee			GPS Latitude/Longitude	
				Start	End
Item	Vegetation			38.188260 °	38.188260 °
				-121.648701 °	-121.648700 °
DWR ID	DWR_RD0501_02_s _ 2012_21				
Comment Code					
V2 : Remove the wild growth other than native grasses from the levee slopes.					
Inspector Comment					
Mow the tall weeds at toe of levee slope.

Looking downstream from levee mile 0.00 at the landside slope tall weeds present on the slope and and toe.

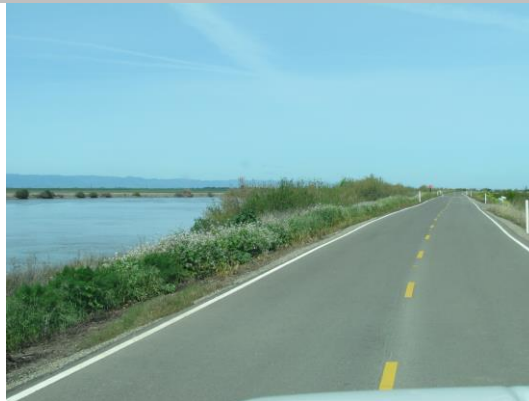
Photo 1 of 1 : SP_2016_RD0501_170_9_20160504_00044.jpg

LM Start	0.49	Rating **	U	Issue No.	9
LM End	3.51	Issue Type +	Ma	Location *	WS
Category	Earthen Levee			GPS Latitude/Longitude	
				Start	End
Item	Vegetation			38.190509 °	38.227237 °
				-121.656805 °	-121.673078 °
DWR ID	DWR_RD0501_02_s_2012_9				
Comment Code					
V2 : Remove the wild growth other than native grasses from the levee slopes.					
Inspector Comment					
District has scheduled this section to be mowed after the Fish/Game restrictions has been released. Until that time there is an unsatisfactory rating being applied.

Looking downstream from levee miles 0.49-3.51 tall weeds present on the water ward shoulder and slope.

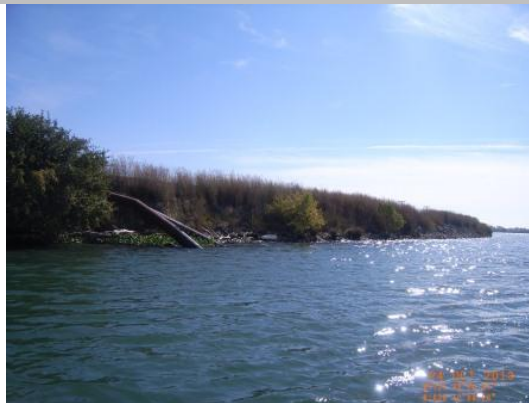
Photo 1 of 1 : SP_2016_RD0501_170_1_20160223_00001.jpg

LM Start	1.10	Rating **	M	Issue No.	1
LM End	1.17	Issue Type +	Ma	Location *	WS
Category	Supplemental			GPS Latitude/Longitude	
				Start	End
Item	2015 USACE Erosion Survey, DRAFT			38.199128 °	38.200146 °
				-121.655881 °	-121.655638 °
DWR ID	DWR_RD0501_02_s_2016_1				
Comment Code					
Inspector Comment					
2005 - Large vertical sections due to wave wash. New stone dumped on the bank with exposed geotextile. Cohesive toe has thin weak stratigraphic unit that is washing out. 2006 - Partially repaired, but 100 ft in the middle of the reach has exposed filter fabric and stone riprap is gone. 2010 - Site extended downstream to include new erosion pocket. 2015: No observed changes. [2015 Site ID: CHS 15-9 L]

USACE 2013 Photo #1

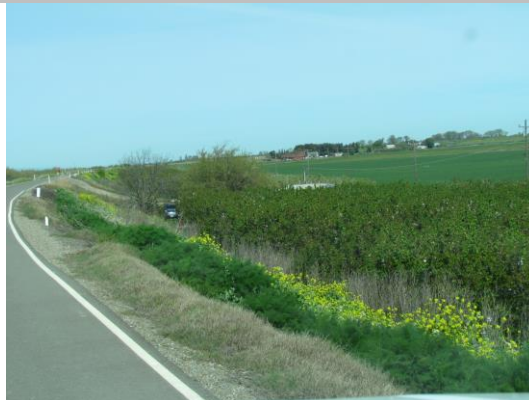
Photo 1 of 1 : SP_2016_RD0501_170_27_20160504_00042.jpg

LM Start	2.49	Rating **	U	Issue No.	27
LM End	3.38	Issue Type +	Ma	Location *	LS
Category	Earthen Levee			GPS Latitude/Longitude	
				Start	End
Item	Vegetation			38.213868 °	38.225330 °
				-121.665767 °	-121.672805 °
DWR ID	DWR_RD0501_02_s_2016_27				
Comment Code					
V2 : Remove the wild growth other than native grasses from the levee slopes.					
Inspector Comment					
Remove the wild berries from the levee section landward.

Standing at levee mile 2.49-3.38 looking downstream landside slope and toe wild berries present on the slope and toe.

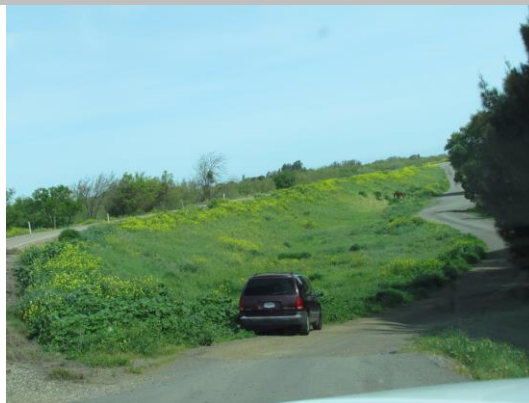
Photo 1 of 1 : SP_2016_RD0501_171_34_20160504_00065.jpg

LM Start	0.00	Rating **	U	Issue No.	34
LM End	0.90	Issue Type +	Ma	Location *	LS
Category	Earthen Levee			GPS Latitude/Longitude	
				Start	End
Item	Vegetation			38.227957 °	38.238723 °
				-121.673078 °	-121.664853 °
DWR ID	DWR_RD0501_03_s_2016_34				
Comment Code					
V1 : Control annual grass and weeds on the levee slopes and easements.					
Inspector Comment					
Remove the wild weed growth on the landward levee slope.

Looking downstream from levee mile 0.00 Unit 3 landside tall mustards and other wild present on the slope and toe.

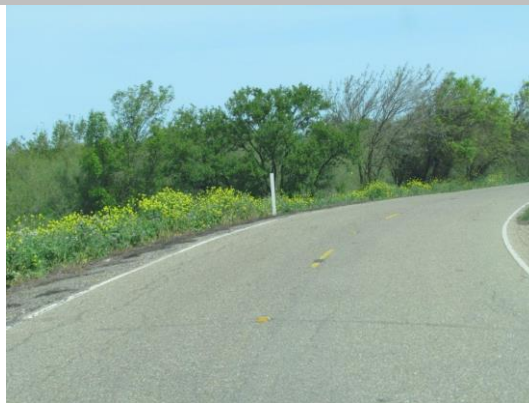
Photo 1 of 1 : SP_2016_RD0501_171_32_20160504_00066.jpg

LM Start	0.00	Rating **	U	Issue No.	32
LM End	2.99	Issue Type +	Ma	Location *	WS
Category	Earthen Levee			GPS Latitude/Longitude	
				Start	End
Item	Vegetation			38.227957 °	38.261668 °
				-121.673078 °	-121.649473 °
DWR ID	DWR_RD0501_03_s_2016_32				
Comment Code					
V1 : Control annual grass and weeds on the levee slopes and easements.					
Inspector Comment					
Control the wild growth of weeds and other vegetation on the waterside slope.

Looking downstream from levee mile 0.00 to 2.99, tall weeds and wild growth present on the levee slope and shoulder.

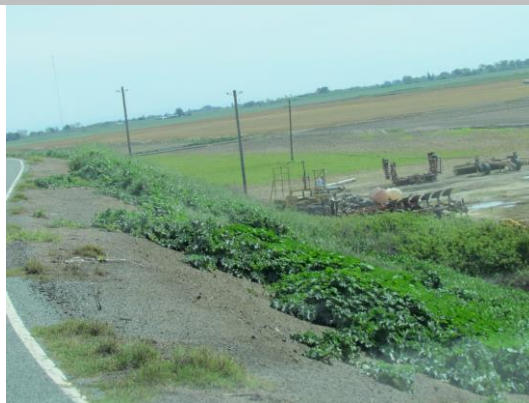
Photo 1 of 1 : SP_2016_RD0501_171_35_20160505_00067.jpg

LM Start	2.25	Rating **	U	Issue No.	35
LM End	3.08	Issue Type +	Ma	Location *	LS
Category	Earthen Levee			GPS Latitude/Longitude	
				Start	End
Item	Vegetation			38.254328 °	38.262442 °
				-121.654775 °	-121.648140 °
DWR ID	DWR_RD0501_03_s_2016_35				
Comment Code					
V1 : Control annual grass and weeds on the levee slopes and easements.					
Inspector Comment					
Remove the wild growth of milkweeds from the levee section.

Looking downstream from levee miles 2.25-3.08 large milkweeds present on the landward slope.

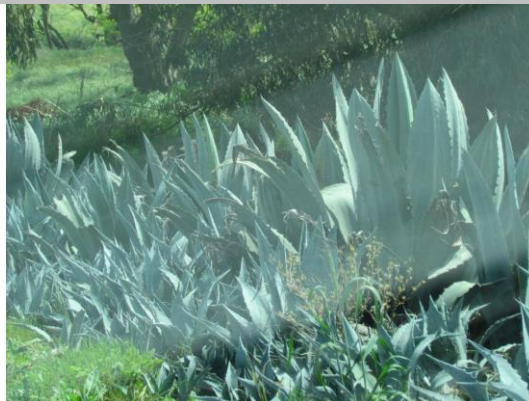
Photo 1 of 1 : SP_2016_RD0501_171_41_20160505_00068.jpg

LM Start	7.65	Rating **	U	Issue No.	41
LM End	7.70	Issue Type +	Ma	Location *	LS
Category	Earthen Levee			GPS Latitude/Longitude	
				Start	End
Item	Vegetation			38.285813 °	38.285537 °
				-121.607003 °	-121.606138 °
DWR ID	DWR_RD0501_03_s_2016_41				
Comment Code					
V2 : Remove the wild growth other than native grasses from the levee slopes.					
Inspector Comment					
This plant growth listed at this location needs to be controlled. This type of plants grows very fast and will completely cover the levee section. (Agave Americana) common names centuryplant, maguey, or American aloe.

Looking downstream from levee mile 7.65-7.70 wild plant growth covering the landside shoulder and slope.

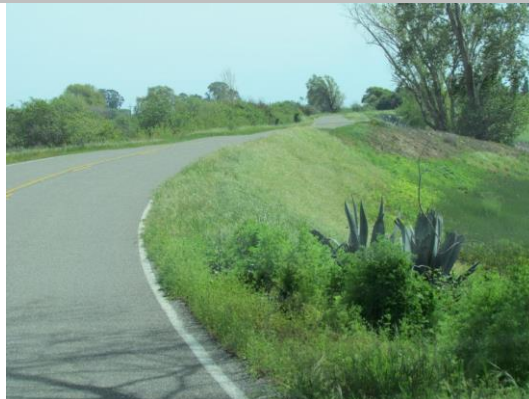
Photo 1 of 1 : SP_2016_RD0501_172_14_20160505_00028.jpg

LM Start	0.00	Rating **	A	Issue No.	14
LM End	2.17	Issue Type +	Ma	Location *	LS
Category	Earthen Levee			GPS Latitude/Longitude	
				Start	End
Item	Vegetation			38.285493 °	38.255978 °
				-121.606042 °	-121.601013 °
DWR ID	DWR_RD0501_04_s_2016_14				
Comment Code					
V1 : Control annual grass and weeds on the levee slopes and easements.					
Inspector Comment					
Levee section looks good from 0.00 - 2.17 landside slope.

Looking downstream from levee mile 0.00 - 2.17 landside of Unit 4.
